UNITED STATES ENVIRONMENTAL PROTECTION AGENCY
Region I – New England

DATE: March 11, 2013

SUBJ: Inspection Report
Hull, MA WWTP
MA0101231

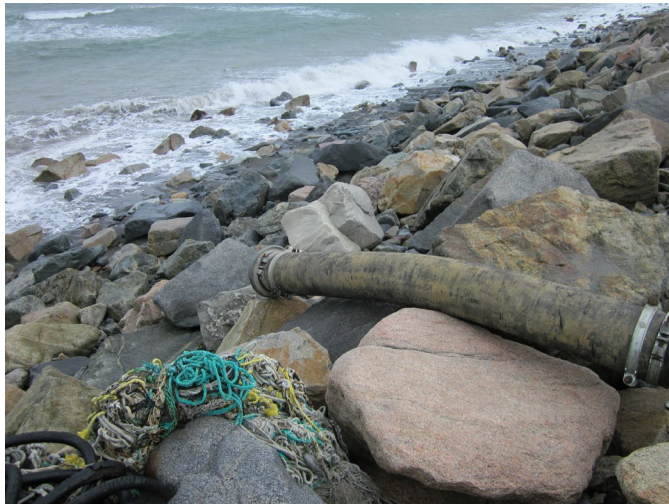
Photo 1. Emergency Bypass to Boston Harbor (not active at time of insp)

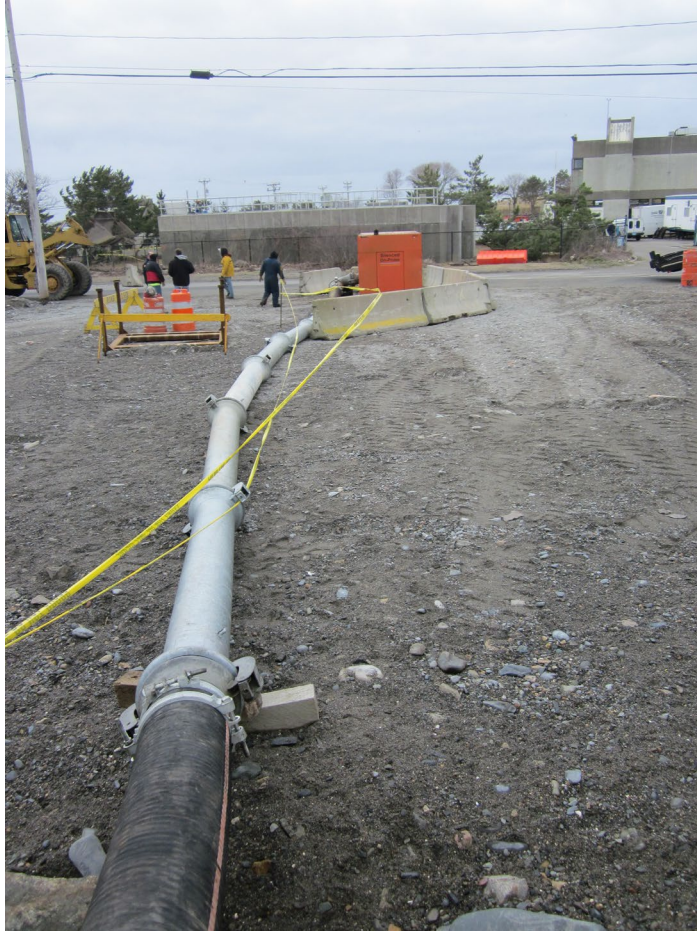
Photo 2. Armoring of emergency bypass effluent pump underway in the event of storm surge associated with storm anticipated that evening.

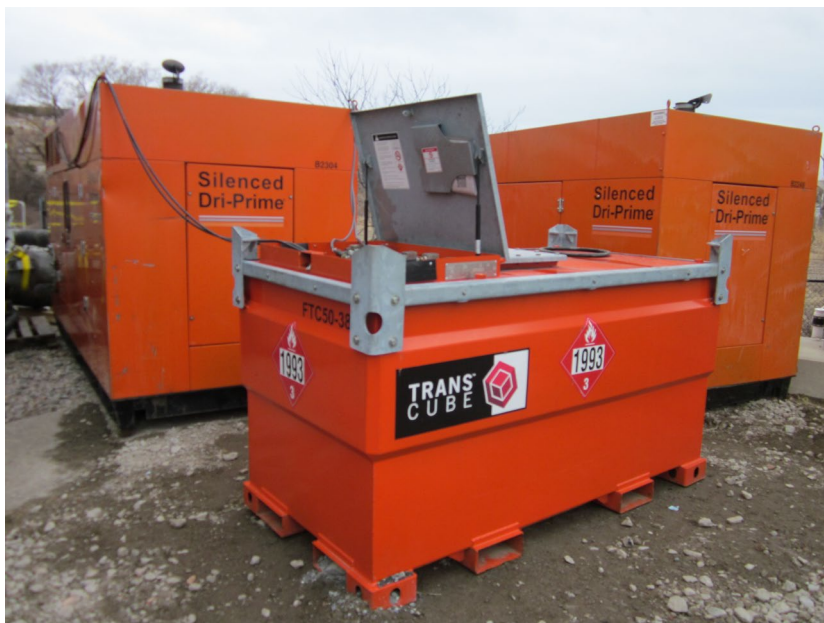
Photo 3: Portable fuel tank and emergency power generators in place for influent pumping.

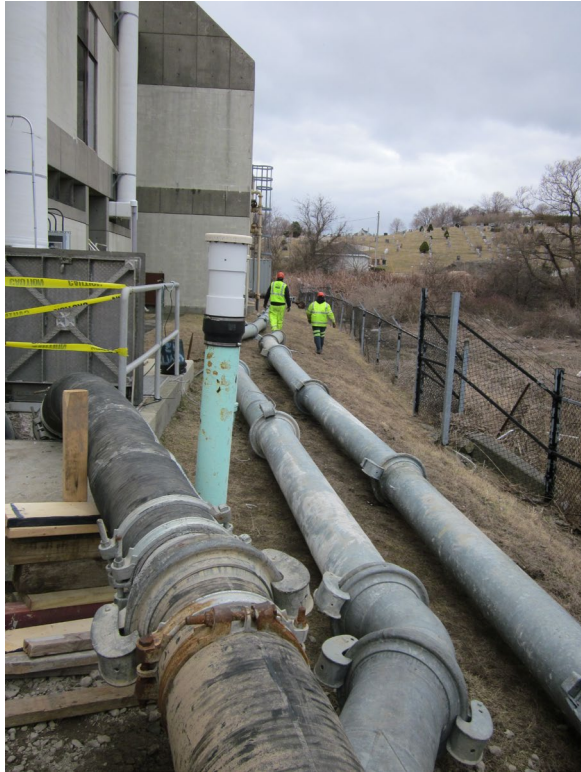
Photo 4: Temporary pumping to influent wetwell.

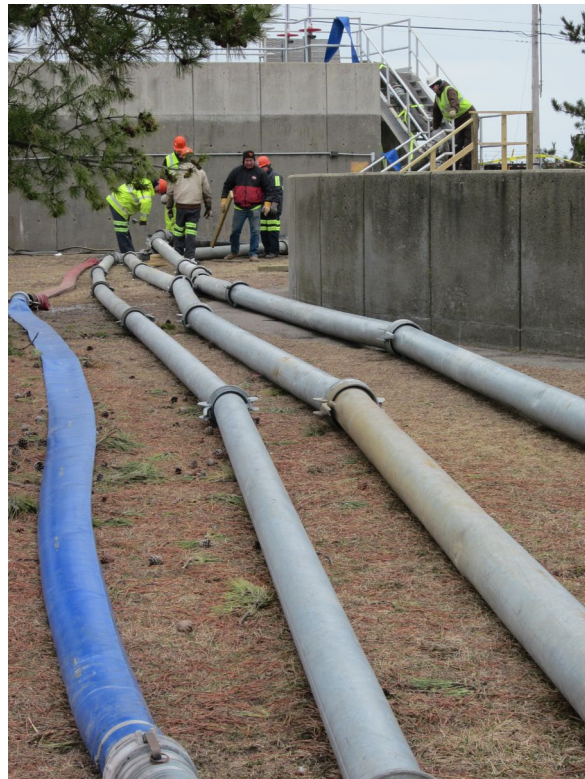
Photo 5: Temporary pumping of treated effluent to chlorine contact chamber.
